# Manhole Inspection Summary

Manhole # S43E\_\_057MH

**Location** Address: **14 BETHEL-BROADWAY-ALLEY** Cross Street: **E LOMBARD ST**

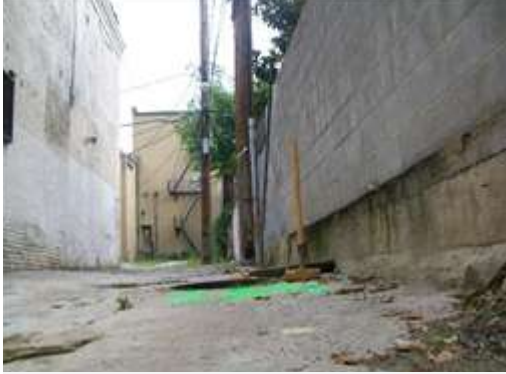
Location View

Comments **LOCATED IN ALLEY; FORCED OPEN WITH 16LB MAUL AND SPRAY LUBRICANT**

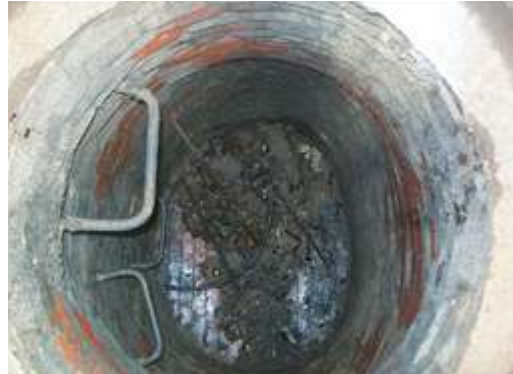
Defect 1

**Channel** Material: **Brick** ☐ Parged  
Channel Exposure: **Fully Open** Junc Dist: **0** nearest .5 ft. Azimuth: **0**  
Condition: ☐ Sound ☐ Cracked ☐ Root Intrusion ☐ Deteriorated ☐ Leaks ☒ **Debris**

DEBRIS IN TERMINAL CHANNEL

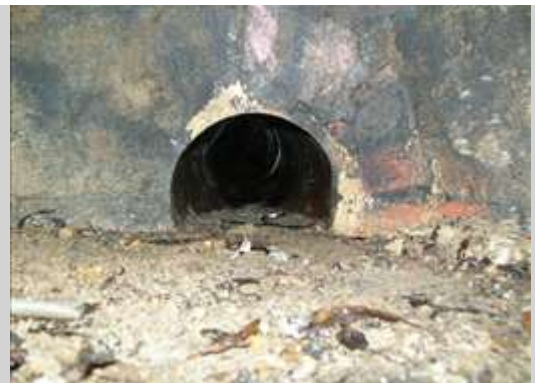
12 O'Clock Outflow

8 in. Circular Gravity Sewer  
Pipe Out @ 12 O'Clock

Deposits: ☐ None ☒ **Mud** ☐ Sludge ☐ Debris ☐ Grease

Silt Depth: **1** (in.) Deposits Extent: **Light**
